## The influence of energy attenuating aircraft seats on lumbar spine burst fractures: an incident reconstruction

Geoffrey T. Desmoulin\*, Kevin G. Bird  
and Alexander R. MacIntosh

GTD Scientific Inc.,  
2306 – 1550 Fern St.,  
North Vancouver, BC, V7J-0A9, Canada  
Email: gtdesmoulin@gtdscientific.com  
Email: kgbird@gtdscientific.com  
Email: armacintosh@gtdscientific.com

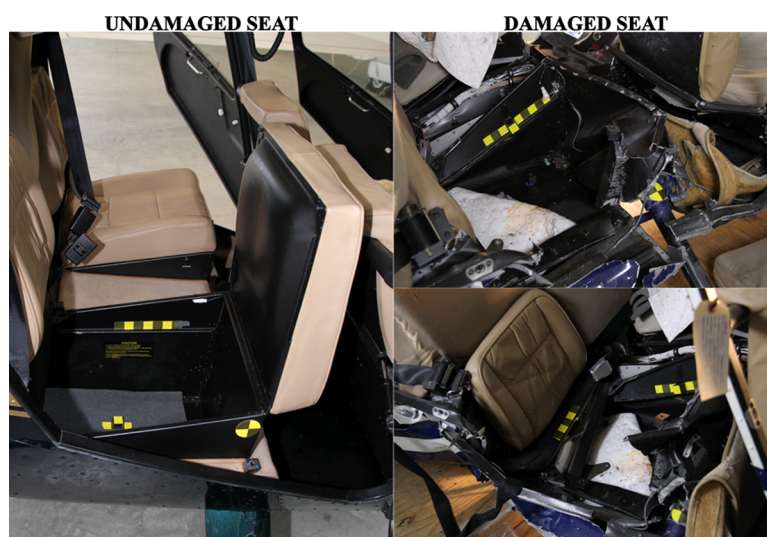
**Figure 2** Rear right seat comparison from undamaged to post-incident (damaged) (see online version for colours)

An examination of the rear right seat, after the incident, revealed that the seat experienced vertical buckling, as indicated by folding of the box panels along the front and inside walls of the seat (Figure 2). Additionally, vertical buckling of the rear box panel and the oblique orientation of the inside box panel (approximately 30 degrees from horizontal) indicates a posterior displacement of the top edge of the front panel. The greatest downward displacement was seen at the right rear corner, with apparent ‘bottoming out’ as compared to the downward displacement of the left rear corner or front panel.

Considering the deformation sustained with each seat, it can be reasoned that at initial impact there was a large vertical component directed downwards and a horizontal component that ran from the initial point of contact at the right rear skid tube (strut) and through the cabin, fore the centre of mass (CoM) causing an axial rotation of the fuselage to the left. The inertial properties of the human mass sitting in each seat would then push to the right causing the midline shift of the seat-buckling pattern.

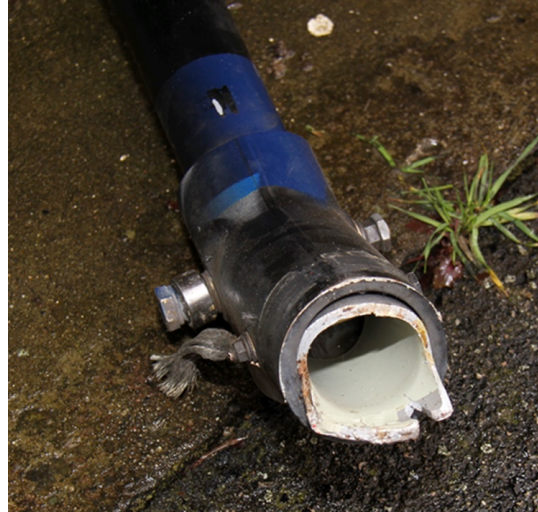
**Figure 3** Crosstube break off point (see online version for colours)

To validate the load bounds described above, it is relevant to examine the forces required to fracture the crosstube of the landing strut seen in Figure 3. When the helicopter first impacted the ground, the force of the impact on the strut travelled through different sections of the helicopter until it reached the passenger of interest. Therefore crosstube failure analysis allowed for validation of forces applied at the seat.

From the image available, it is known that the landing strut failed in bending due to tension at the top of the tube and compression at the bottom. Coupled with information about the location of said crosstube, it is possible to calculate force vector magnitude and impact angle the moment the helicopter struck the ground.

Based on the failure mode described by the cross-section seen in Figure 3, it is also known that the strut failed in tension on the top portion and compression on the bottom.

These loadings point to an impact of approximately 23°. This angle refers to the difference between the direction of the force vector applied to the crosstube and the horizontal plane of the aircraft. Considering that the crosstube is known to have impacted with a hill, a 23° collision appears reasonable and validates the bounds of loads estimated to be present.

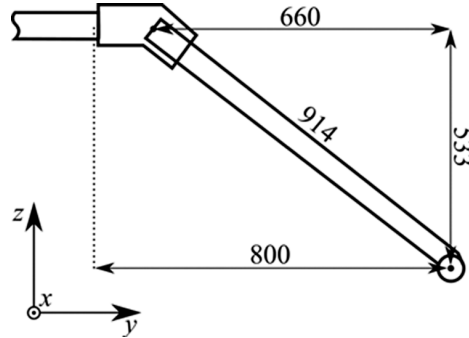
**Figure 4** Measurements of the rear right landing gear viewed from behind including coordinates system used in calculations (dimensions in mm)

This crosstube was located just aft of the cabin and on the right side. Information gathered about the case helicopter revealed that this part was made of 7075-T6 drawn aluminium tubes, which have an ultimate tensile strength of 531 MPa. Symbols used in failure calculations are listed in Table 1 and dimensions of assembly are shown in Figure 4.

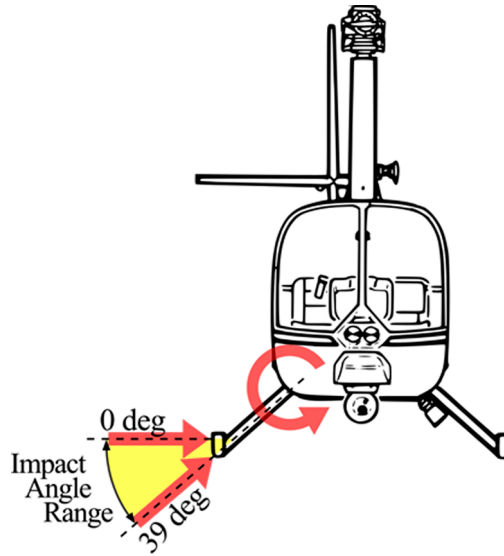
**Figure 5** Range of impact angle to create the appropriate load (see online version for colours)

This suggests that the crosstube was driven towards the midline of the aircraft. As shown in Figure 5, to generate such a moment, the angle of impact on the landing strut could not have reached more than  $39^\circ$  from horizontal. This angle represents the angle of the strut itself with the horizontal. A force at this exact angle would have resulted in a compression failure of the crosstube instead of the flexion failure observed. The horizontal angle, also denoted as  $0^\circ$ , is another limit of this range since past this angle, the vertical component to the passengers would have been in a direction opposite of what would cause a compression of the seats. Therefore, the  $0$  to  $39^\circ$  range of Figure 5 is the only range possible to generate the injuries seen in the passenger as well as the damage exhibited by the aircraft.

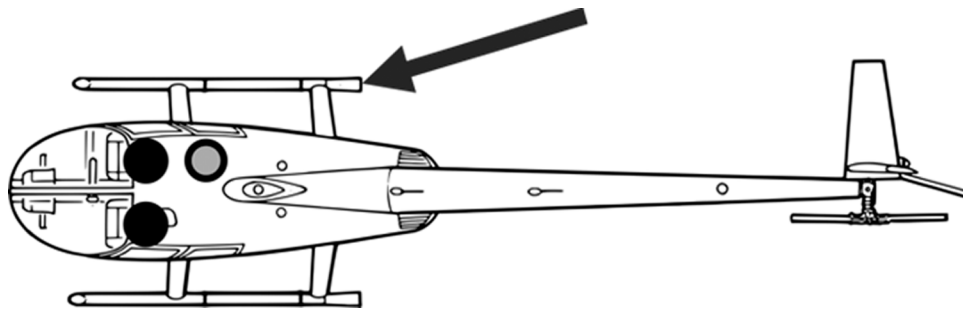
**Figure 6** Top view of force vector resultant and position of each occupant in aircraft

As an indicator of the horizontal PDOF applied to each seat, the resultant direction of displacement was calculated given the measured displacement of the available edges. This resultant showed a leftward and anteriorly orientated force vector as illustrated by Figure 6.

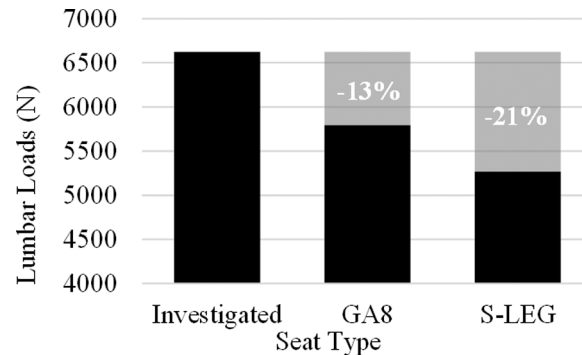
**Figure 9** Energy absorbing seat comparison

Another seat technology was also available at the time, as shown in a 1997 publication by Lankarani and Ng (1997). In another 32 G vertical impact test, a seat equipped with deformable S-shaped legs, made from aluminium 2024-T351, as shown in Figure 8, displayed energy-absorbing properties beyond that of both the incident seat and the U-shaped aluminium box of the GA8 aircraft. The lumbar load registered on a 50th percentile anthropomorphic test dummy (ATD) was 5614 N. To compare this value to the 30 G pulse used to test the other two seats, a correction factor can be applied using the method proposed in AC27-1B (Circular, 1999). This correction further reduced the load to 5262 N. As shown in Figure 9, the additional attenuation, when compared with the incident seat is 21%.

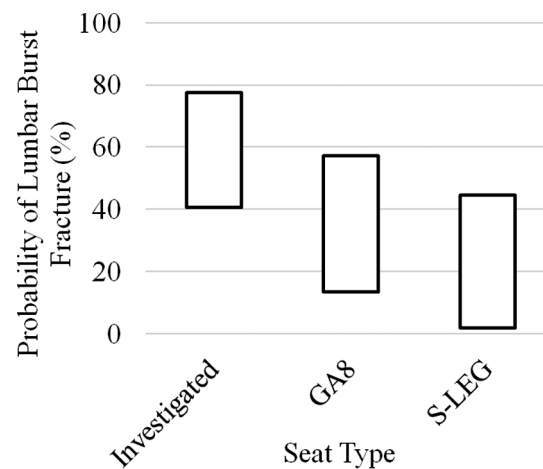
**Figure 10** Probability of lumbar region burst fracture using each seat (lower to upper bound)

It is possible to obtain injury probabilities using this seat performance data together with the burst fracture tolerance information previously reported herein. Injury probability analysis suggested that burst fracture risk to the passenger of interest would have decreased from 40–78% with the incident seat to 2–45% with the S-shape design. Effectively, this difference suggest a risk of injury that is ‘more probable than not’ with the incident seat and an injury that is ‘less than likely’ with the alternative but available seat design (see Figure 10).
