Contribution of Injury Biomechanics to Traffic Collision Reconstructions:
A Case Report

Geoffrey Thor Desmoulin, Marc-André Nolette, Kevin Gordon Bird

Contribution of Injury Biomechanics to Traffic Collision Reconstructions: A Case Report

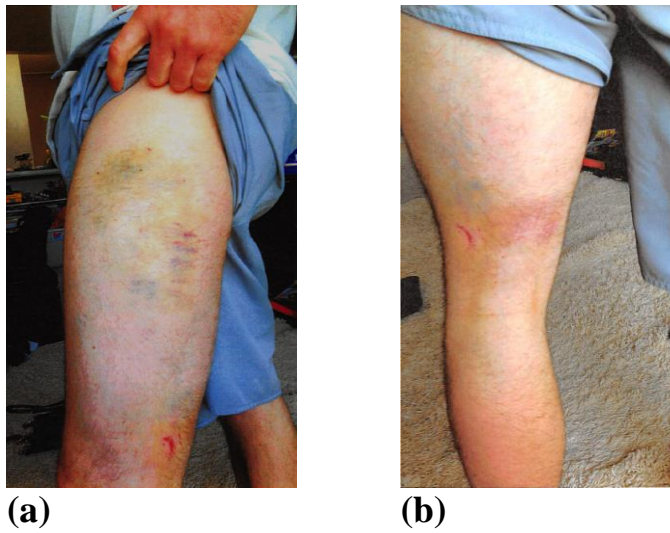
One such abrasion appears to be present on the side of Rider #2's left leg above the knee, as a dark red semicircular crescent shape. Upon closer inspection, it also appears to be devoid of hair in the immediate vicinity of the abrasion indicating a tangential type of contact. This information can be used to determine likely contact points of Rider #3's motorcycle, which, in turn, can then be used to determine the motorcycles orientation at the time of impact.

This discoloration can be seen on both views from Figure 1 as various shades of blue, purple and yellow. View (a) of Rider #2's left leg shows a large oblong contusion pattern centered on the lateral aspect of the thigh while view (b) shows a straight uniformly colored purple bruise on the more distal and posterior side of the thigh. These patterns can be used to match contact points with Rider #3's motorcycle, which can then be used to determine both motorcycles orientation at the time of impact.

The injuries shown in Figure 1 were likely caused by the impact between the two riders. The side impact described by Rider #3 is most plausible and the following analysis shows how Rider #3's motorcycle could have caused the injuries in question.

Figure 1: Abrasions and discoloration to (a) side and (b) back of Rider #2's left leg.

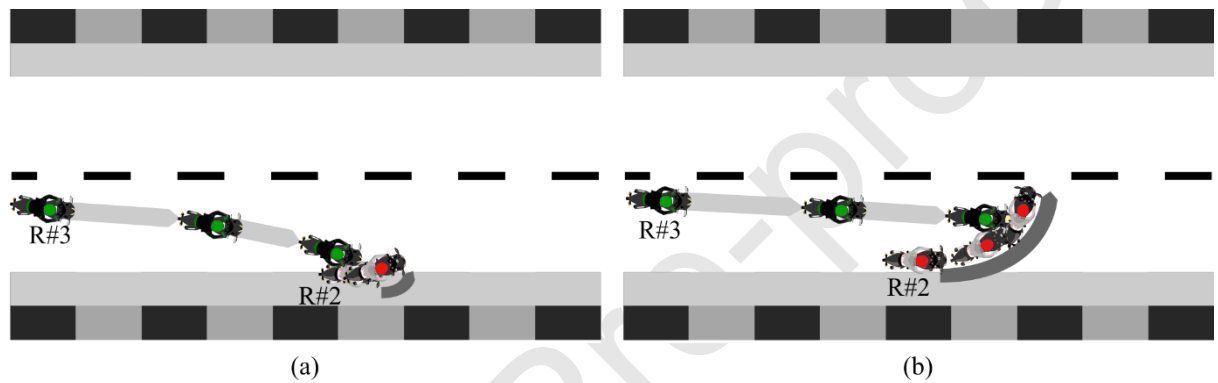
These four aspects of the investigation all point towards the conclusion that the impact was more likely than not perpendicular in nature. This would place Rider #2 in the middle of the lane in a perpendicular orientation to the road. This is best represented by Figure 2(b).

Figure 2: Bird's-eye view illustration of description of the incident from (a) Rider #2 and (b) Rider #3.

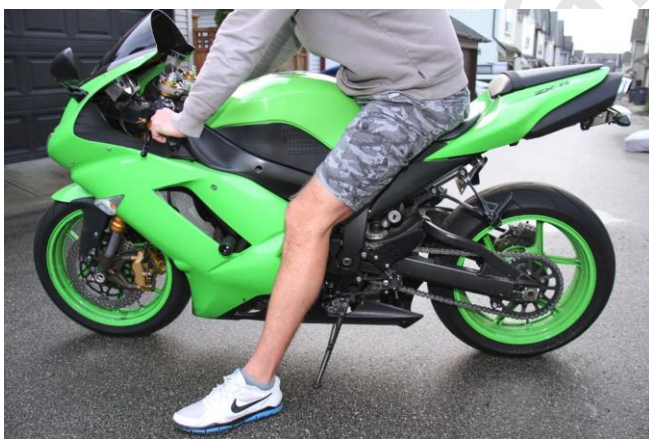
The first important initial parameter of the impact is Rider #2's leg position. In Rider #2's version of the events, he states he was stopped with his left foot on the ground. Therefore, at the time of the impact, his leg would have been lowered, and so, likely as depicted in Figure 3 below. Rider #3's version of the events states that Rider #2 was performing a U-turn with his foot barely off the road. Rider #2 having his leg down during the turn is consistent with the technique used for turning on a dirt bike. Rider #2 learnt to ride a dirt bike at the age of 5 years old and then transitioned into driving a motorcycle in adulthood. Due to these statements and riding habits, it is likely that he would have his leg in a similar position as depicted in Figure 3. Therefore in both scenarios, it is likely that Rider #2's left leg was lowered and not on the foot peg.

Figure 3: Motorcycle owner demonstrating stopped position on a 2008 Kawasaki Ninja ZX-6R.

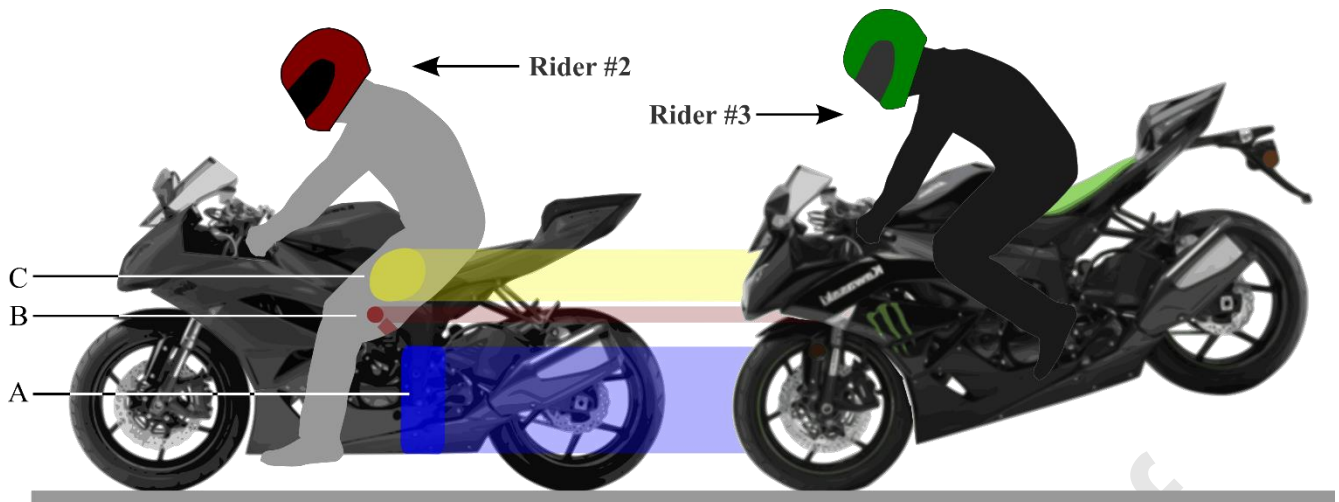
Although the area of contact is similar between both accounts, neither completely explain the bruising pattern on the left leg and the lack of damage to the left side of Rider #2's motorcycle. During the impact, Rider #2 received a large contusion on the lateral surface of his left thigh as well as a contusion and crescent-shaped mark slightly above the posterior-lateral surface of his knee. These injuries do not match the shape or the height of Rider #3's motorcycle front tire. However, it is consistent with Rider #3's front tire hitting the solid steel frame of Rider #2's motorcycle just behind his left leg. This explains the lack of damage to the left side of his motorcycle as the compliant front tire impacted and deformed against the relatively rigid steel frame. Figure 4 shows the location of Rider #3's front tire impact (A).

The pitch angle of Rider #3's motorcycle was compared to the regions of the crescent-shaped mark and contusion shown in Figure 1. To do so, Rider #3's motorcycle was modelled with the back wheel rising from the pavement. The angle was then modulated to find the angle that best matched the injury pattern on Rider #2's left thigh. The result can be seen in Figure 4.

The large contusion on Rider #2's hip matches the location of the front fairing of Rider #3's motorcycle (C) and the crescent-shaped mark matches a notch found on both sides of the front fairing (#2). Unfortunately, because the front fairing of Rider #3's motorcycle was torn off during the incident it was not possible to view the notch of the incident motorcycle itself in images taken at the scene. Instead, the notch shape was investigated during the inspection of a motorcycle of the same year and model. A close-up view of the notch found on a 2008 Kawasaki Ninja ZX-6R is included in Figure 5 below.

A dimensional analysis of Rider #3's motorcycle revealed that the notches are approximately 6.3 inches away from the centerline of the motorcycle and approximately 3.8 inches away from the edge of the front tire horizontally. Therefore, Rider #3's tire is able to impact Rider #2's frame at location A without contacting his lower leg while the notch and associated fairing can impact his lower and upper thigh region (B and C) since they are offset horizontally from the tire by approximately 3.8 inches. Further, Rider #2's riding stance prior to the collision places his calf forward of where the tire would have impacted. This means that there was enough room for the tire to hit the motorcycle and for the front fairing to come into contact with Rider #2's thigh, thus leaving the marks identified as B and C in Figure 4.

Figure 4: Height of impacts to Rider #2 and his motorcycle compared to the height of various locations on Rider #3's motorcycle at the matched motorcycle angle.

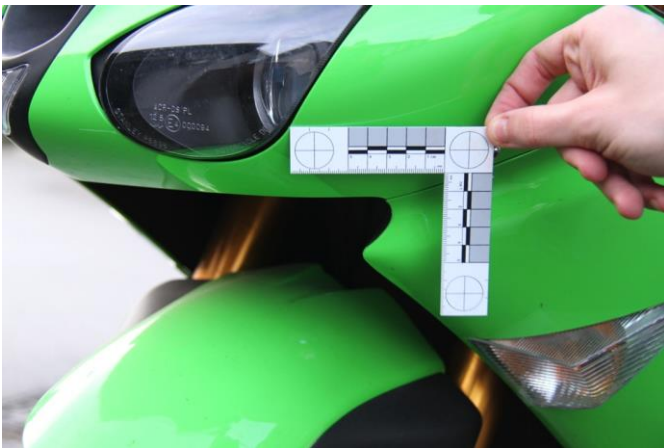
The crescent-shaped mark on Rider #2's leg shows typical signs of tangential contact with an object. The object appears to be the left side notch of the front fairing shown in Figure 5. If Rider #2's motorcycle had been aligned with the road as Rider #2 claimed, the contact between the motorcycles would have been more rearward or tangential and would now have correspond to the front fairing pattern identified.

Figure 5: Notch on the left side of the front fender of the 2008 Kawasaki Ninja ZX-6R inspected during the full-scale motorcycle examination.

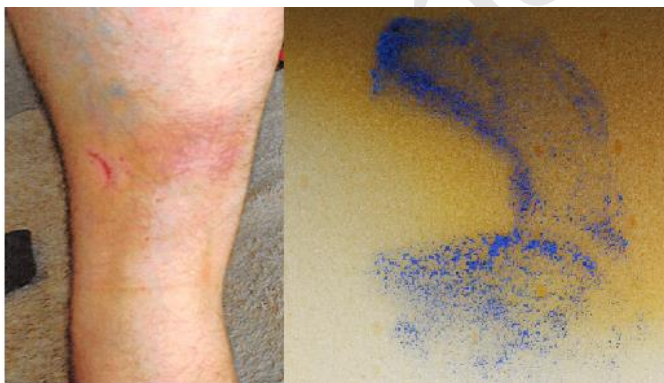
The resulting chalk imprint on the foam was then compared to images of Rider #2's thigh as shown in Figure 6. The chalk imprint can be seen as having a similar shape and curvature to the crescent-shaped mark on Rider #2's leg. Additionally, the left side of Figure 6 shows Rider #2 also had a contusion above the back of his knee in line with the crescent-shaped mark. This contusion could be attributed to the force of the associated fairings impact.

Figure 6: Comparison of the abrasion on Rider #2's leg and the imprint of the notch left on the foam.

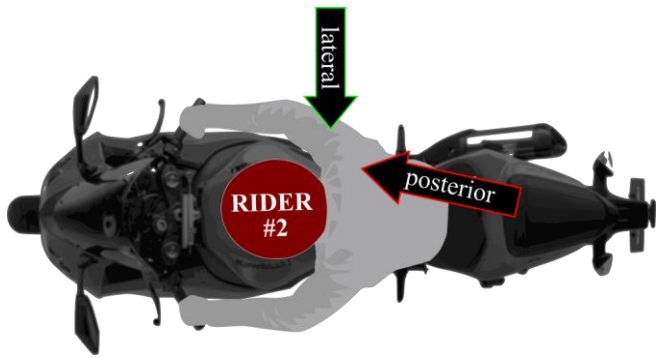
Bassett, 1992). Such blows to the back of the shoulder would be more likely to cause scapular injuries (Heckman et al., 2015). Though blows to the posterior aspect of the shoulder can be responsible for displaced clavicle fractures, these loads must include a mid-line direction (medial) and overall compression of the shoulder girdle in order to load the clavicle for fracture. Similarly, a more likely mechanism would involve an impact originating from the right side as shown in Figure 7.

In fact, the lateral load associated with Rider #2's clavicle injury is most often caused by falls or direct lateral compressive blows (see section 4). It is, therefore, more likely that a fall to the right side of his motorcycle caused the clavicle fracture. Clavicle fracture literature (Stanley et al., 1988) suggests that a force between 2 to 4 times the bodyweight is sufficient to generate such a fracture given that the impact is along the axis of the clavicle (lateral from the shoulder).

Figure 7: Orientation of force on Rider #2's upper body.
