Contribution of injury biomechanics to traffic collision reconstructions: A case report

Geoffrey Thor Desmoulin ^{*}, Marc-André Nolette, Kevin Gordon Bird

GTD Scientific Inc, 2037 MacKay Ave, North Vancouver, BC V7P 2M8, Canada

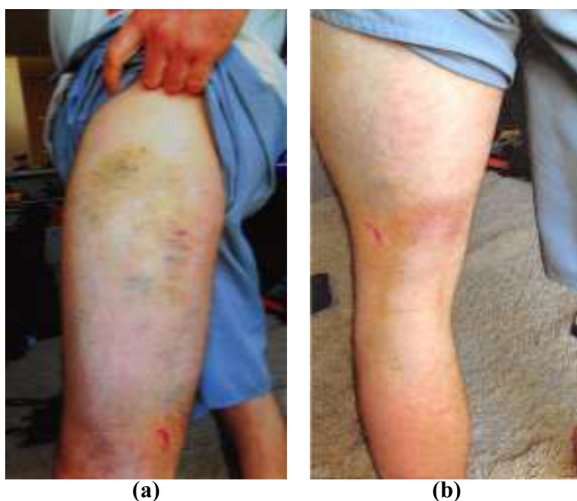
Fig. 1. Abrasions and discoloration to (a) side and (b) back of Rider #2's left leg.

One such abrasion appears to be present on the side of Rider #2's left leg above the knee, as a dark red semicircular crescent shape. Upon closer inspection, it also appears to be devoid of hair in the immediate vicinity of the abrasion indicating a tangential type of contact. This information can be used to determine likely contact points of Rider #3's motorcycle, which, in turn, can then be used to determine the motorcycles orientation at the time of impact.

This discoloration can be seen on both views from Fig. 1 as various shades of blue, purple and yellow. View (a) of Rider #2's left leg shows a large oblong contusion pattern centered on the lateral aspect of the thigh while view (b) shows a straight uniformly colored purple bruise on the more distal and posterior side of the thigh. These patterns can be used to match contact points with Rider #3's motorcycle, which can then be used to determine both motorcycles orientation at the time of impact.

The injuries shown in Fig. 1 were likely caused by the impact between the two riders. The side impact described by Rider #3 is most plausible and the following analysis shows how Rider #3's motorcycle could have caused the injuries in question.

The pitch angle of Rider #3's motorcycle was compared to the regions of the crescent-shaped mark and contusion shown in Fig. 1. To do so, Rider #3's motorcycle was modelled with the back wheel rising from the pavement. The angle was then modulated to find the angle that best matched the injury pattern on Rider #2's left thigh. The result can be seen in Fig. 4.

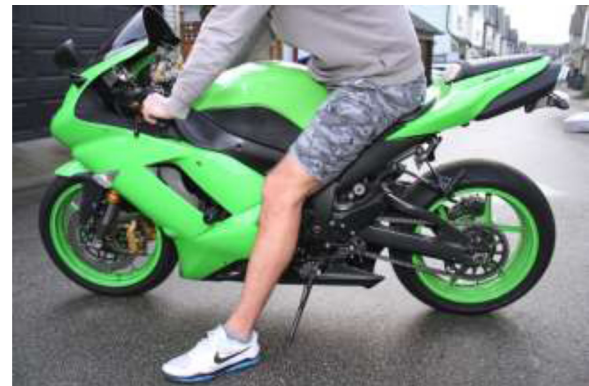
Fig. 3. Motorcycle owner demonstrating stopped position on a 2008 Kawasaki Ninja ZX-6R.

Although the area of contact is similar between both accounts, neither completely explain the bruising pattern on the left leg and the lack of damage to the left side of Rider #2's motorcycle. During the impact, Rider #2 received a large contusion on the lateral surface of his left thigh as well

as a contusion and crescent-shaped mark slightly above the posterior-lateral surface of his knee. These injuries do not match the shape or the height of Rider #3's motorcycle front tire. However, it is consistent with Rider #3's front tire hitting the solid steel frame of Rider #2's motorcycle just behind his left leg. This explains the lack of damage to the left side of his motorcycle as the compliant front tire impacted and deformed against the relatively rigid steel frame. Fig. 4 shows the location of Rider #3's front tire impact (A).

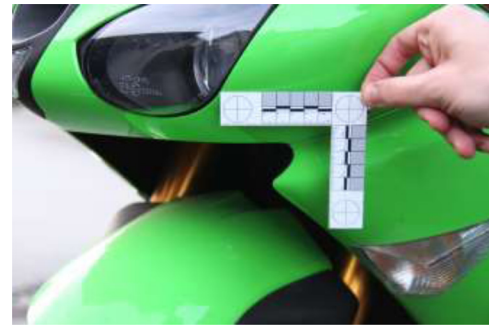
The large contusion on Rider #2's hip matches the location of the front fairing of Rider #3's motorcycle (C) and the crescent-shaped mark matches a notch found on both sides of the front fairing (#2). Unfortunately, because the front fairing of Rider #3's motorcycle was torn off during the incident it was not possible to view the notch of the incident motorcycle itself in images taken at the scene. Instead, the notch shape was investigated during the inspection of a motorcycle of the same year and model. A close-up view of the notch found on a 2008 Kawasaki Ninja ZX-6R is included in Fig. 5 below.

A dimensional analysis of Rider #3's motorcycle revealed that the notches are approximately 6.3 in. away from the centerline of the motorcycle and approximately 3.8 in. away from the edge of the front tire horizontally. Therefore, Rider #3's tire is able to impact Rider #2's frame at location A without contacting his lower leg while the notch and associated fairing can impact his lower and upper thigh region (B and C) since they are offset horizontally from the tire by approximately 3.8 in.. Further, Rider #2's riding stance prior to the collision places his calf forward of where the tire would have impacted. This means that there was enough room for the tire to hit the motorcycle and for the front fairing to

Fig. 5. Notch on the left side of the front fender of the 2008 Kawasaki Ninja ZX-6R inspected during the full-scale motorcycle examination.

The crescent-shaped mark on Rider #2's leg shows typical signs of tangential contact with an object. The object appears to be the left side notch of the front fairing shown in Fig. 5. If Rider #2's motorcycle had been aligned with the road as Rider #2 claimed, the contact between the motorcycles would have been more rearward or tangential and would now have correspond to the front fairing pattern identified.
