## The influence of energy attenuating aircraft seats on lumbar spine burst fractures: an incident reconstruction

Geoffrey T. Desmoulin\*, Kevin G. Bird  
and Alexander R. MacIntosh

GTD Scientific Inc.,  
2306 – 1550 Fern St.,  
North Vancouver, BC, V7J-0A9, Canada  
Email: gtdesmoulin@gtdscientific.com  
Email: kgbird@gtdscientific.com  
Email: armacintosh@gtdscientific.com

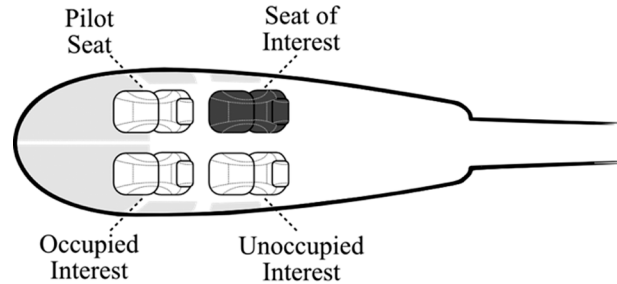
**Figure 1** Seating arrangement of the aircraft

Injuries to the occupants ranged from minor to fatal. The current investigation focuses on one surviving occupant who suffered a lumbar burst fracture as a result of the crash. As shown in Figure 1, this occupant was seated in the back row on the right side. More specifically, focus was placed on the potential risk mitigation that could have been granted by energy absorbing seats, which were commercially available at the time of manufacturing but not installed in this particular helicopter.
