Forensic application of inverse and reverse projection photogrammetry to determine subject location and orientation when both camera and subject move relative to the scene^{\star}

We present a case study of a mountain bicycle accident captured by the rider's chest-mounted action camera. The objective of the investigation was to determine the orientation of the bicycle relative to the ground and the location of the rider's center of gravity relative to the bicycle. The problem faced in the investigation was that the camera was moving relative to the scene and rider, and the bicycle was moving relative to the camera. Inverse photogrammetry was used to determine the location and orientation of the camera relative to the scene. Reverse projection photogrammetry applied to an exemplar bicycle provided an estimate of the location and orientation of the bicycle relative to the camera. The rider's position and orientation relative to the camera were estimated by comparing synchronized side views and chestmounted action camera views of the rider's movements, recorded during a trail descent prior to the accident.

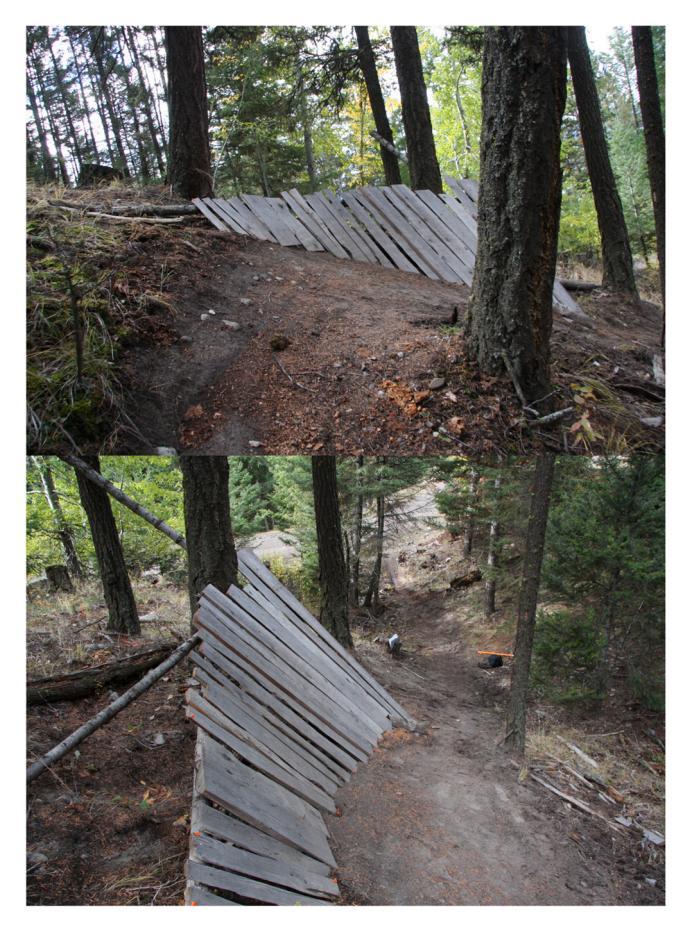
Fig. 1. Section of trail leading up to ramp jump (top) and section of trail below ramp (bottom).

The incident setting was a downhill mountain bike trail where a sharp (approximately 90°) turn of the trail was followed by a ramp constructed from rough wooden planks built against a large tree and banked at approximately 45° (Fig. 1). Dimensions of the ramp were obtained from a land survey of the incident scene conducted several months later. The end of the ramp was approximately 1.4 m above the ground at its highest point. The trail dropped with a significant slope beyond the ramp and passed close to another large tree, located to the left of the trail, approximately 2 m from the edge of the ramp. The front wheel of the bicycle first touched the ground near the base of this tree. The survey data placed the point where the front wheel of the bicycle first touched the ground at approximately 2 m below the highest point on the ramp. A high-definition 3D laser scan of the incident scene was conducted 28 months after the incident as part of an investigation into the cause of the injury,

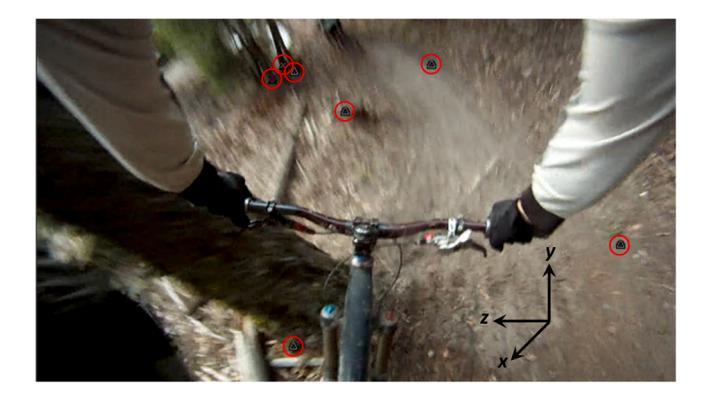
Fig. 2. Single frame from action camera image of bicycle and trail as front wheel touched the ground below the ramp. Control points are circled in red. Coordinate convention shown at bottom right. (For interpretation of the references to colour in this figure, the reader is referred to the web version of this article.)

The image corresponding to the first contact of the front wheel with the ground after the jump was identified from the incident video taken by the rider's action camera (Fig. 2). Five control points in the image were selected and matched to corresponding points in the 3D laser scan of the incident scene. PhotoModeler software then performed inverse photogrammetry to estimate the location and orientation of the camera in the reference frame of the 3D laser scan, hereafter referred to as the external reference frame. The Photo-Modeler output provided the location of the center of the camera image in the coordinates of the external reference frame and the Cardan angles of the camera, which represent a sequential rotation around each coordinate axis required to bring the coordinate axes of the camera into alignment with the coordinate axes of the external reference frame. PhotoModeler represents the optical axis of the camera along the *z*-axis and the plane of the camera image as the *xy*plane. The 3D laser scan represented gravitational vertical along the *y*-axis and the horizontal plane as the *xz*-plane, where the wooden ramp was traversed primarily along the negative *x*-direction (Fig. 2). The pitch angle, relative to the horizontal plane was of primary importance in this investigation. The pitch angle can be calculated using the rotation matrix specified by the Cardan angles by defining a vector along the optical axis of the camera and multiplying it by the rotation matrix. This transforms the vector so that it is represented in terms of the coordinates of the external reference frame. The pitch angle of the camera is equal to the cosine angle of the transformed vector relative to the horizontal plane.

PhotoModeler requires a minimum of 5 control points. To determine the precision of PhotoModeler's inverse photogrammetry algorithm when there are a limited number of control points available, 7 control points were selected from the action camera image (Fig. 2) and matched to positions in the point cloud of the 3D laser scan. The control points encompassed a large portion of the selected action camera image. The 7 control points served as a set from which the 21 possible subsets of 5 control points were created. These 21 subsets served as 21 different inputs to PhotoModeler. The 21 different outputs of PhotoModeler's inverse photogrammetry algorithm, i.e. the predicted locations and orientations of the camera, were then analyzed using descriptive statistics. The standard deviation provided an estimate of the precision of the inverse photogrammetry methodology.

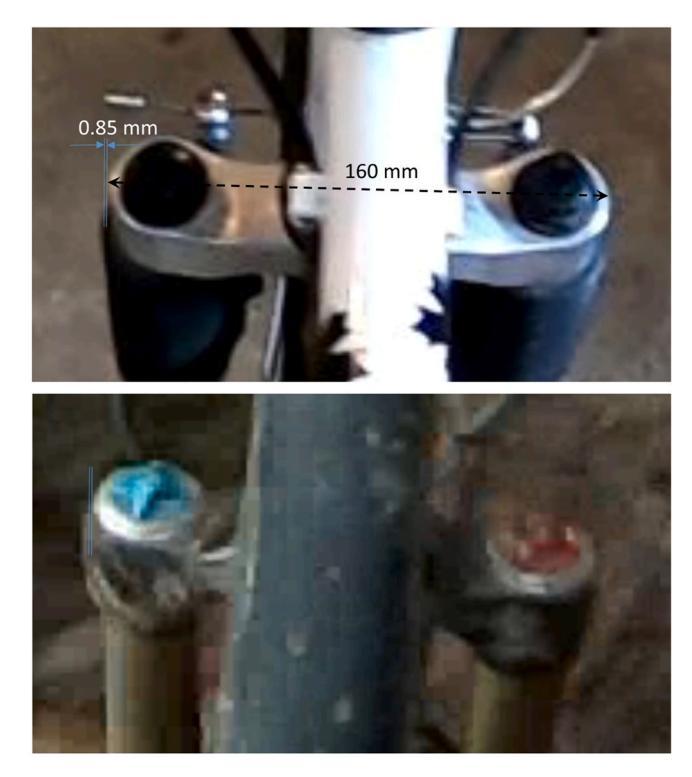
Fig. 3. Comparison of images of the fork crown of the exemplar bicycle (top), taken with a.

GoPro Hero 8, and the incident bicycle (bottom), taken with the incident GoPro, at the same scale. Parallel blue lines on the left of the images depict the minimum detectable horizontal shift in image position, which is similar for the two cameras and estimated to be 0.85 mm. (For interpretation of the references to colour in this figure, the reader is referred to the web version of this article.)

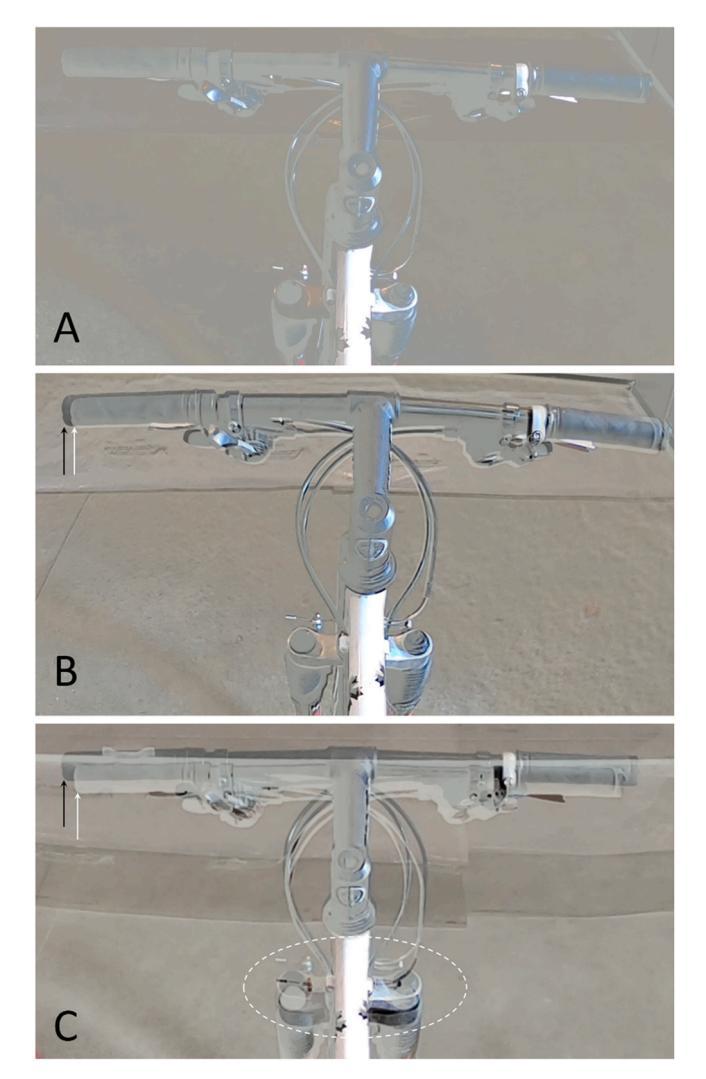
Fig. 4. Overlaid images of a mountain bike aligned on steerer tube clamp (center of images). A. Overlay of identical images serve as reference of perfect match. B. Overlay of images from same camera pitch angle but 1.5 cm difference in distance from the camera to handlebar stem. Dark and light arrows point to more and less distant camera positions, respectively. Note difference in handlebar alignment and length. C. Overlay of images from the same camera position, but with 1.5° difference in camera pitch angle. Dark and light arrows correspond to smaller and greater pitch angles, respectively. Note difference in handlebar alignment and length. Note difference in front fork alignment shown inside dashed oval.

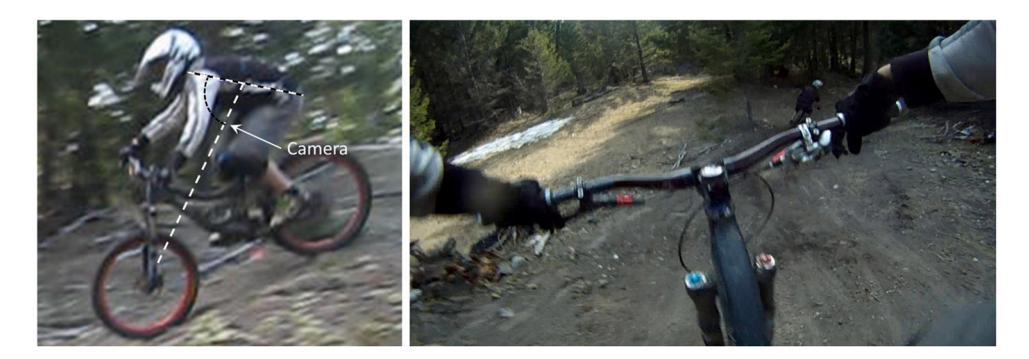
Fig. 5. Side view and chest mount view from video frames matched in time. Side view shows chest mount camera location. Dashed line from camera to front fork indicates lower limit of camera field of view. Angle between line from rider's shoulder to hip and lower limit of camera field of view indicated by dashed lines is equal to 75°.

We found that the angle between lower limit of the camera's field of view and the line joining the shoulder and the hip generally varied between 65° and 75°, although it could drop as low as 60° or rise as high as 80°. As shown in Fig. 5, under the assumptions of our analysis, the combined center of gravity of the rider and bicycle was located 7.5 cm behind the point of contact of the front wheel with the ground along the horizontal direction. The point of contact of the front wheel with the ground slope of 15°, based on consulting the topographical map of the trail, available on the trail website.

We examined the effect of uncertainty in the pitch angle on the location of the combined centers of gravity by rotating the bicycle to increase the pitch angle by 3° with respect to the horizontal. Note that this is greater than our estimated error in pitch angle of 2.3° but it serves to take into account the uncertainty of 1.5 cm in the distance from the handlebar stem to the camera. The 3° rotation moved the center of gravity forward by approximately 4.5 cm, which placed it approximately in line with the point of contact of the front wheel with the ground after taking into account the shift in contact location produced by rotation of the bicycle (Fig. 7). Assuming that the bicycle landed such that the center of gravity aligned with the point of contact of the front wheel, the motion of the rider's body would still depend on any evasive action that he took prior to and at the time of impact. The body position shown in Fig. 5 represents an

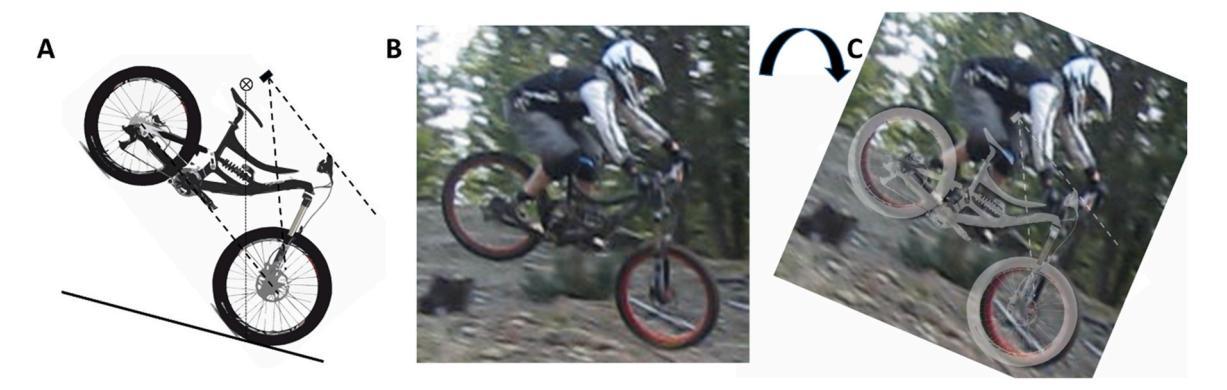
Fig. 6. A. Estimated orientation of bicycle at instant of front wheel contact with the ground and location of combined rider/bicycle center of gravity (crossed circle), assuming ground slope of 15°. Dashed lines indicate optical axis and lower limit of camera field of view. B. Video frame illustrating rider position when landing from a jump. C. Image from B rotated to align with overlaid image of bicycle from A, illustrating postulated position of rider at instant that image in Fig. 2 was recorded.

The reverse projection photogrammetry indicated that the wheelbase of the bicycle was oriented approximately parallel to the optical axis of the camera, i.e. at -53.3° with respect to the horizontal plane (Fig. 6). From our analysis of reverse projected images of the stationary mountain bicycle, we found that differences in handlebar length and front fork alignment between the superimposed images could be reliably detected if the difference in camera pitch angle was 1.5° or greater. Similarly, differences in reverse projected images could be reliably detected if the difference in camera position was 1.5 cm or greater. Therefore, we consider the estimated distance from the camera to the handlebar stem to be accurate to within 1.5 cm and the pitch angle of the bicycle, i.e. the pitch angle of the wheelbase relative to the camera, to be accurate to within 1.5°. However, the uncertainty in the pitch angle of the bicycle relative to horizontal depends also on the uncertainty in the camera pitch angle. We assumed that the error in reverse projection photogrammetry was equivalent to the variance and used the method of combining variances to estimate the total uncertainty in the pitch angle, which gave an uncertainty of 2.3° , i.e. $-53.3^{\circ} \pm 2.3^{\circ}$.

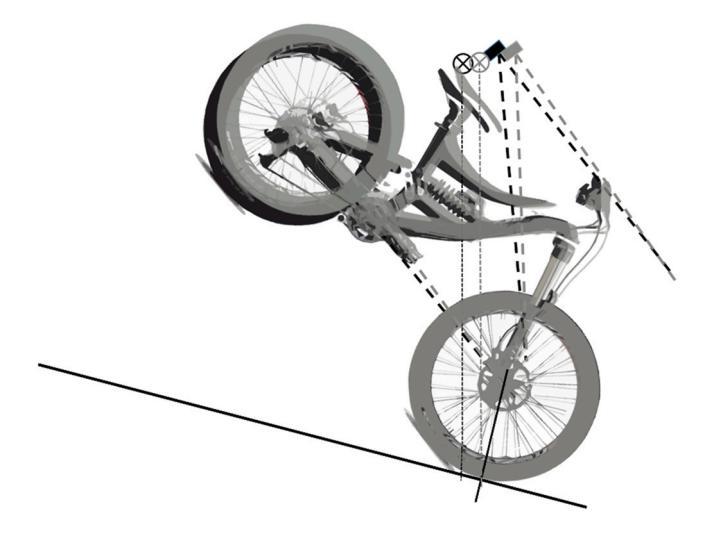
Fig. 7. Image of bicycle in Fig. 5A rotated counterclockwise by 3° to illustrate forward shift of center of gravity.
